# BULLS EYE 2020

APR 2020

## PRODUCT IN FOCUS MXL SERIES UNIVERSAL JOINTS

### HOW TO ANALYZE CONTAMINANTS ON MAGNETIC DRAIN AND FILL PLUGS

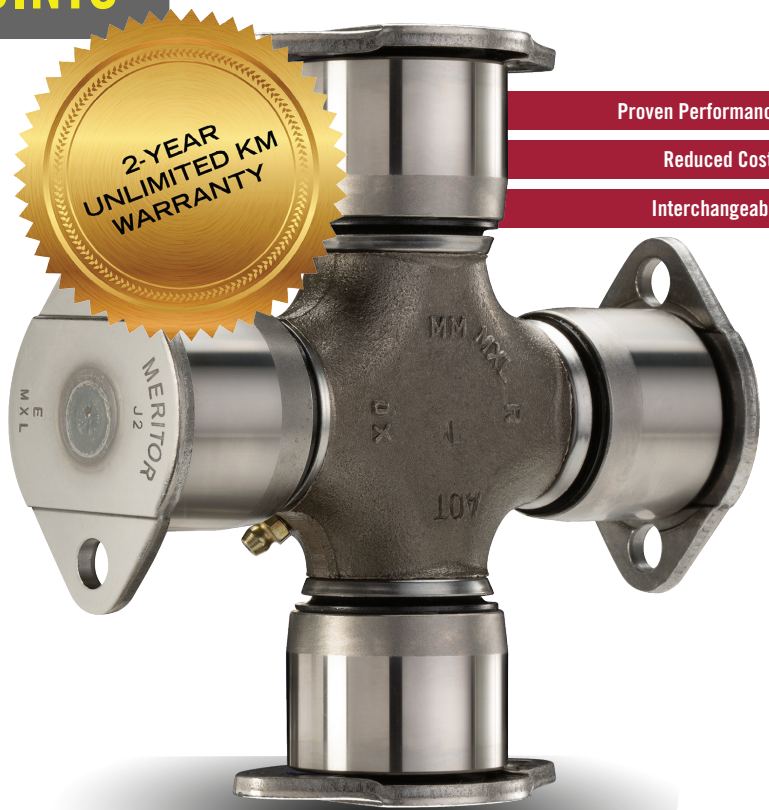
FEATURE	BENEFITS	MERITOR	COMP. A
Nylon Thrust Washer	Eliminates metal to metal contact, reducing wear and extending life.	✓	✗
Advanced Triple Lip Seal	Superior sealing characteristics with triple-lip seal and protective metal deflector. This keeps lubrication in and contaminants out.	✓	✗
Superior Long Bearing Pack	Larger contact surface (20% more than competitors) and a robust bearing retention system provides superior damping force and eliminates spinning cups.	✓	✗
Extended Lube Intervals	Meritor MXL lube intervals are 3x longer than competitors. This saves you or your business in lubrication and service costs.	✓	✗

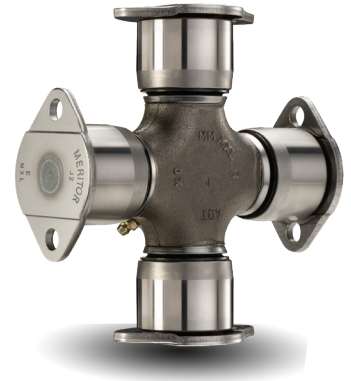
#### Meritor MXL Universal Joint

*High Quality Finish*

*Made in dedicated Meritor factory*

*38 Long Bearings*

*Nylon Thrust Washer*

*Triple Lip Sealing System*

*Full circular solid weld on plate*

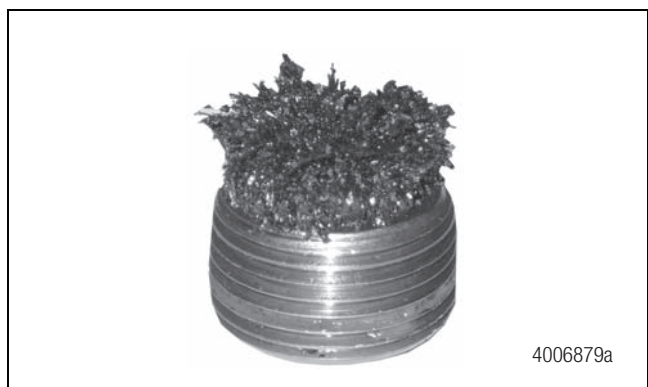
The fine metal particles attached to the magnetic plug in Figure 1 are normal. Internal components can shed fine metal wear particles at a steady rate, especially during the break-in period. In addition to the magnetic plugs, Meritor axles are also equipped with four to six magnets in the housing to capture debris generated during extended maintenance intervals used today.

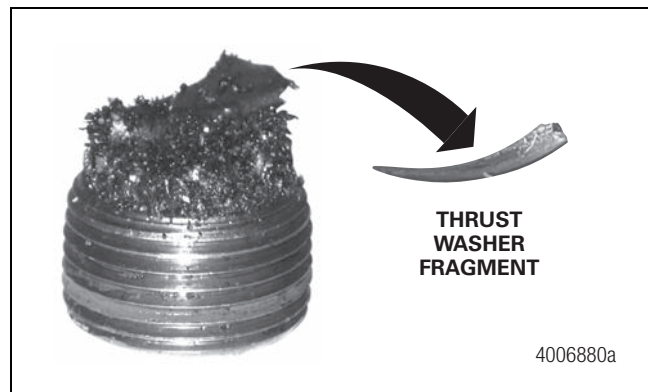
Figure 2 shows a main differential side gear thrust washer fragment. The loss of a fragment from the thrust washer is not detrimental to the operation of the axle and does not require disassembly, inspection and replacement of the axle. If you are concerned about additional fragments or component damage, perform an oil sample analysis. If the iron content of the sample is above 1000 parts per million (ppm), inspect and repair the carrier as necessary.

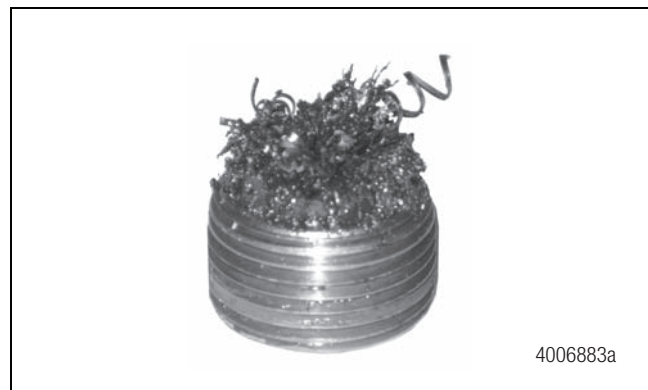
Figure 3 shows metal shavings which are remnants from the housing machining process. Metal shavings adhere to the magnets and are not detrimental to the operation of the axle. It is not necessary to perform further inspections or remove the carrier for cleaning.

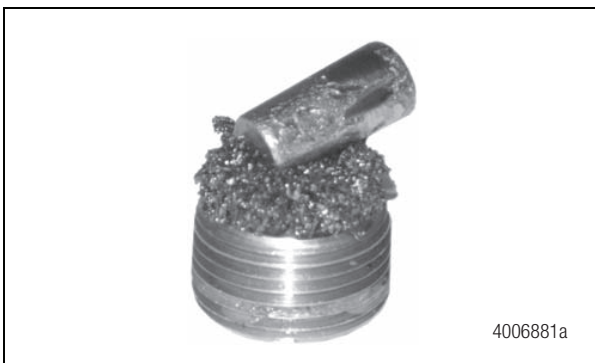
Figure 4 and Figure 5 show bearing and gear tooth fragments. Both indicate a significant issue that can result in component damage. Immediately remove the carrier, inspect it, and perform required repairs.

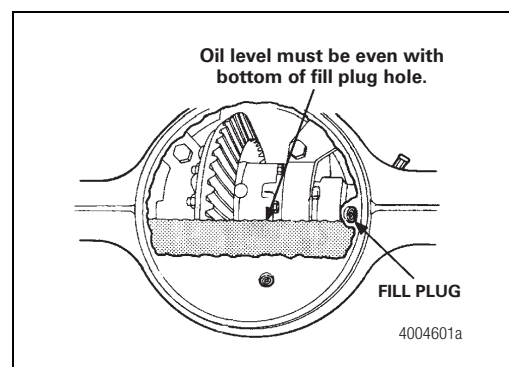
Figure 6

Verify that the lubricant is even with the bottom of the fill plug hole and not below the fill plug hole. If necessary, add the specified lubricant, until it is even with the bottom of the fill plug hole. Figure 6.

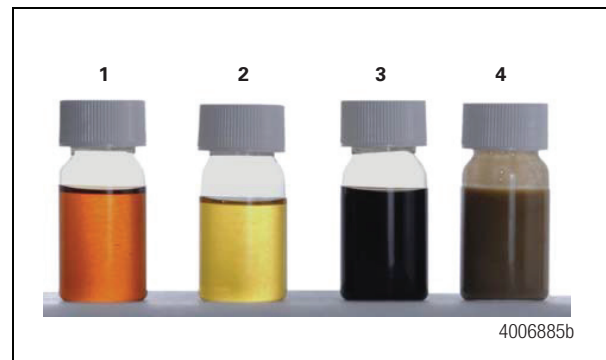
Most drive axle oils are either golden brown or deep red in color. If the oil looks “milky brown” or has a “copper” color, the oil is contaminated. The oil samples in Figure 7 show how the lubricant may appear during inspection. Refer to Oil Conditions for guidelines.

Both the red and golden brown samples show the typical appearance of new GL5 EP oils that meet the SAE J2360 specification. They usually are golden brown, but also can be red in color. Figure 7.

This black sample is used-oil with significant time and mileage. The color change from red or golden brown to black is the result of a normal chemical process that occurs as the additive package in the oil degrades. The black color does not necessarily indicate that the oil’s useful life has been exhausted. Perform a lubrication analysis to verify that the oil can still be used in the carrier. Figure 7.

This “milky” brown sample indicates the oil is contaminated with significant moisture well above

the allowable change specification of  $>0.3\%$ . Change the oil immediately. Locate the source of the moisture. Figure 7.
