# MERITOR® BRAKE CHAMBERS

## FEATURES AND BENEFITS

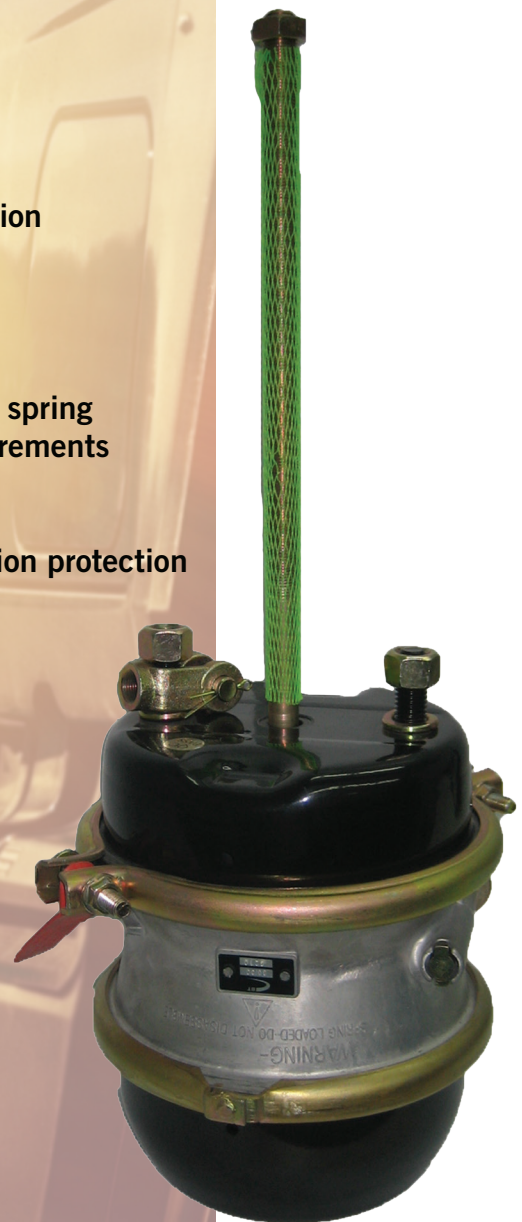
- Steel spring housing with aluminum center section
- Designed for cost conscious customers
- Sealed spring brake (rear section) for O.H.S.

- Corrosion protected standard performance main spring
- Designed and tested to meet performance requirements

- Steel end caps are e-coated for excellent corrosion protection

- Double o-ring and bushing structure

- Size options from 2424 to 3636
- Standard (2.5") stroke options

- Includes release tool and holder
- Tandem, piggyback and service chamber
- Available with clevis

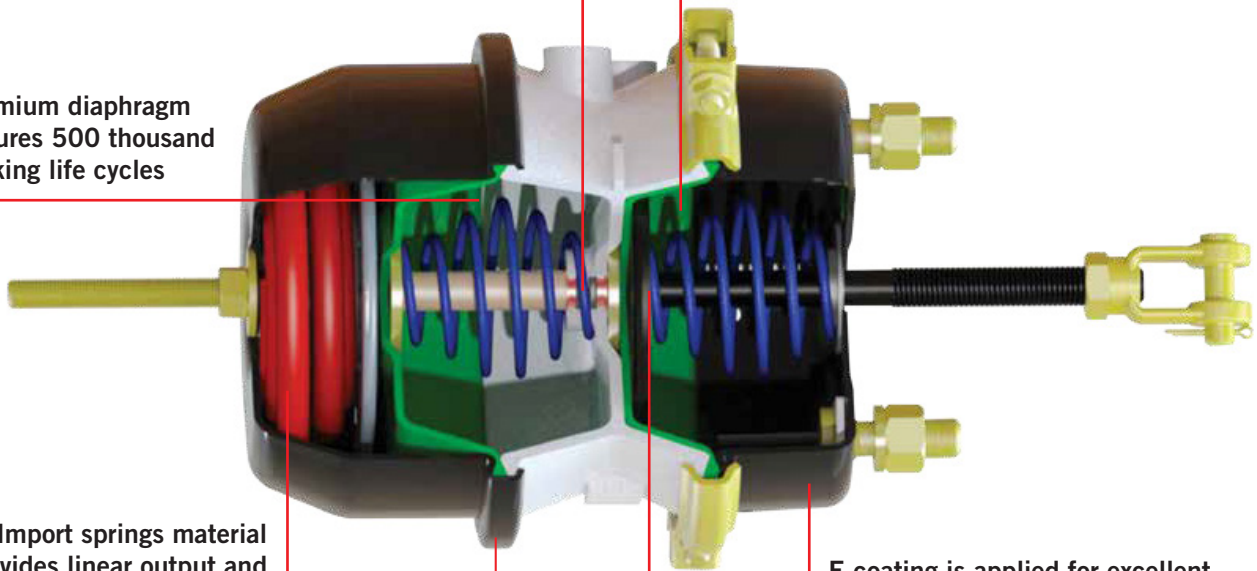
Double O-rings and bushings structure provides the best leak protection and wear resistance

Premium diaphragm ensures 1.2 million chamber life cycles specifications

Premium diaphragm ensures 500 thousand parking life cycles

Import springs material provides linear output and 500 thousand parking life cycles specifications

E-coating is applied for excellent corrosion protection

Sealed spring brake (rear section) for O.H.S.

Drawn arc stud welding is applied for pushrod plate forming a bond that is stronger than the surrounding metal
